# Galloway Centre - External Coating Refurbishment Case Study

**Project Type:** Building Refurbishment and Protective Coatings Application

**Project Scope:** Remedial Repairs, Surface Restoration, Protective Coating Application and Quality Assurance Inspection.

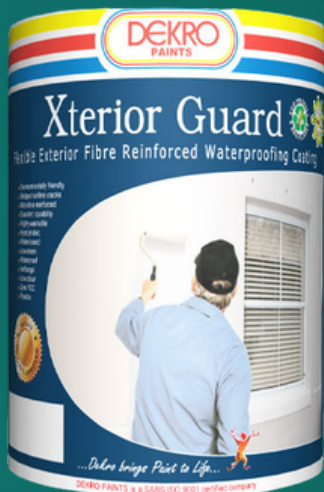
Dekro Xterior Guard is an exceptionally high quality fibre reinforced flexible waterproofing coating with a low sheen.

Dekro Xterior Guard bridges hairline cracks, offers extremely low dirt retention, is highly washable, has good stain resistance, excellent durability and outstanding waterproofing properties.

Dekro Xterior Guard is ideal for applications that require outstanding durability and waterproofing. Designed to cover hairline cracks on old and crazed plaster.

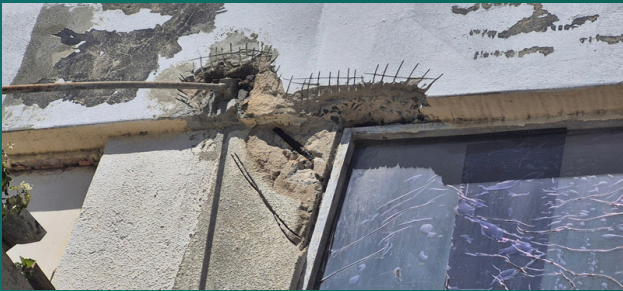
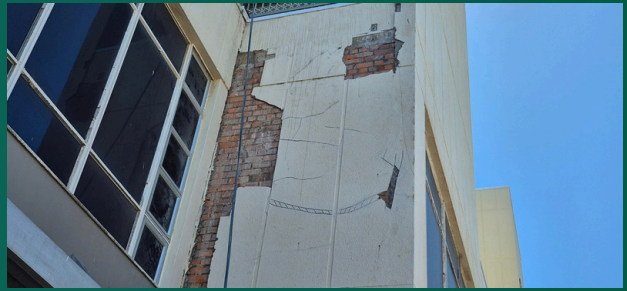
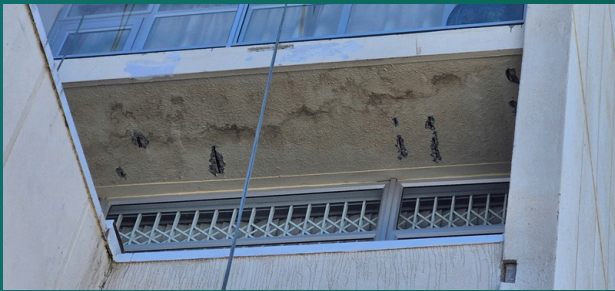
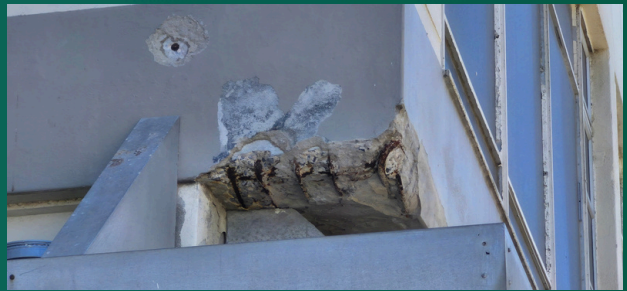
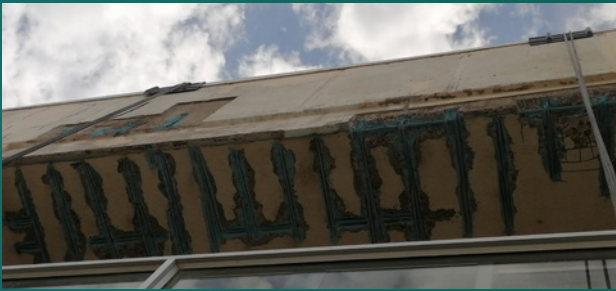
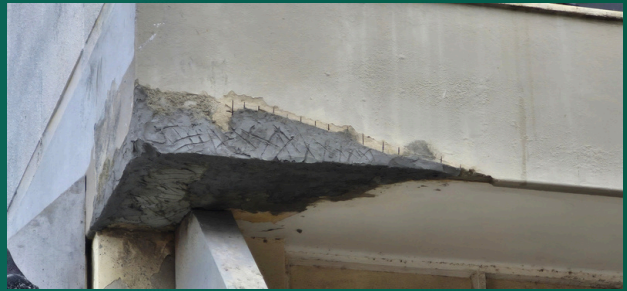
# Remedial Repairs

Thorough external remedial repairs are the most critical step in a commercial painting project because they prevent premature paint failure and protect the building's structural integrity. Skipping this step to save time or money always results in higher long-term costs, as new paint cannot adhere to or protect a damaged substrate.
